**From:** FIA Single-Seater Department

**Re:** Report on the events involving the deployments of recovery vehicles during the 2022 Japanese Grand Prix (FIA Formula One World Championship)

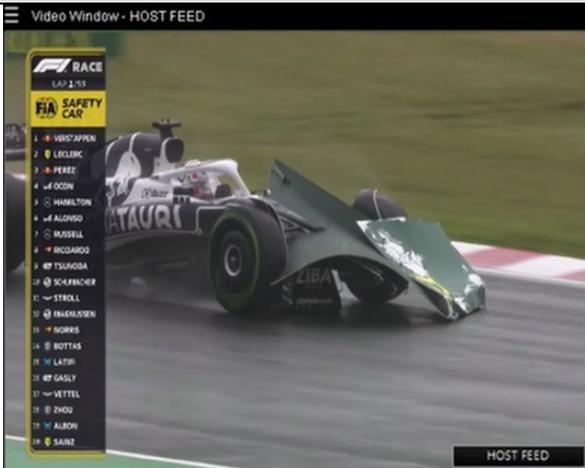
TIMING	EVENTS
<p><b>14:05:05</b> Car #10 (GAS) hits advertising boarding and continues around the track with the advertising board wedged on the front of his car.</p>

Assessment of the current application of advertising boards, their construction, location and materials used to avoid the potential for them to being torn off and thrown on track.	2023	FIA & FOM
Improving the visibility of recovery vehicles by adding extra powerful lights (F1 Rain Lights)	2023-24	FIA & FOM
Circuit drainage improvements in Suzuka	TbD	FIA & FOM

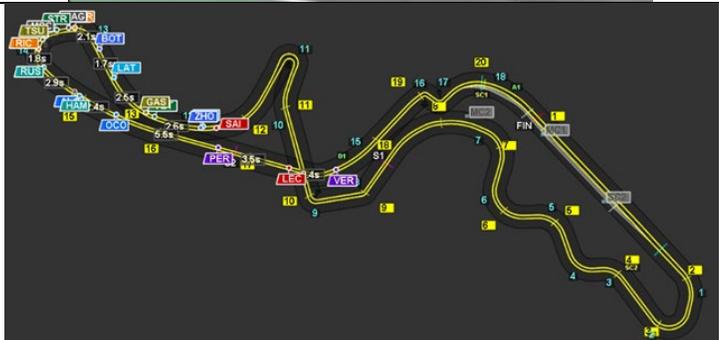
<p><b>14:05:09</b> Safety Car Deployed</p>

<p><b>14:05:28</b> Car #23 (ALB) stops at T12 exit – <i>“Incident 2”</i></p> <p><b>14:05:59</b> Marshals attend Car #23 (ALB)</p>

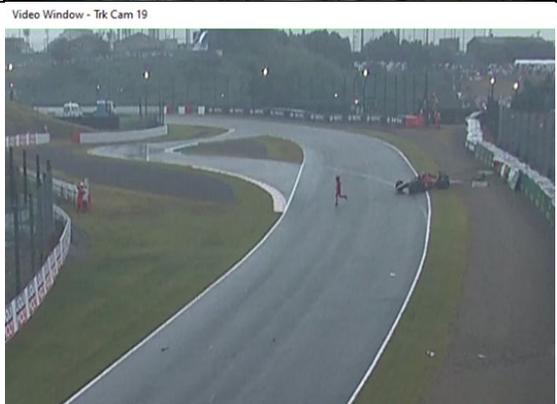
<p><b>14:06:24</b> Car #55 (SAI) runs across the track at T12 having received permission from a track marshal.</p>

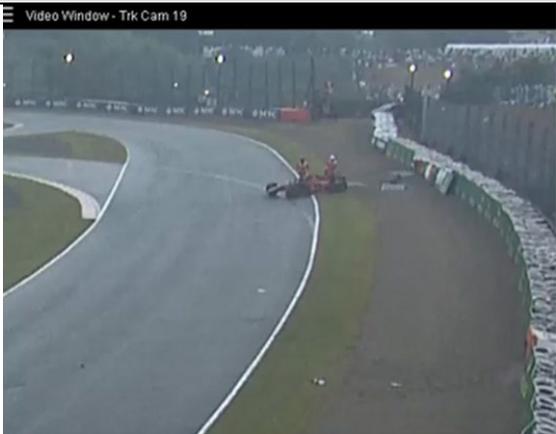
TIMING	EVENTS
<p><b>14:06:25</b> Car #11 (GAS) enters the pit lane</p> <p><b>14:06:32</b> Marshals enter the track at T12 entry under Clerk of the Course and Race Director Instructions – <b>“Incident 1”</b></p> <p><b>14:06:44</b> Marshals attend Car #55 (SAI) – <b>“Incident 1”</b></p>

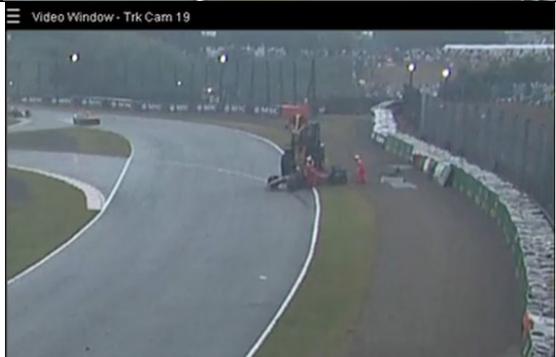
<p><b>14:06:52</b> Crane enters the track at T12 entry – <b>“Incident 1”</b></p> <p><b>14:07:06</b> Car #10 (GAS) exits the pit lane</p> <p><b>14:07:06</b> Crane enters the track at T12 exit – <b>“Incident 2”</b></p> <p><b>14:07:11</b> Crane attends Car #55 (SAI) – <b>“Incident 1”</b></p>

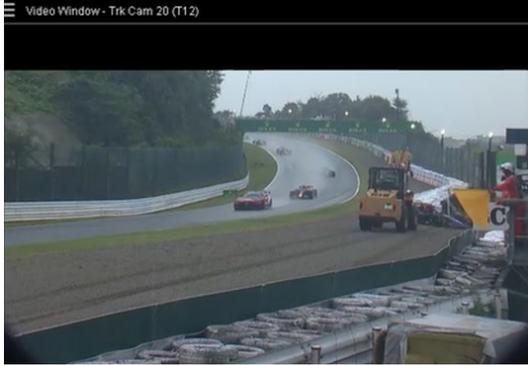
TIMING	EVENTS
<p><b>14:07:26</b> Crane attends Car #23 (ALB) – <b>“Incident 2”</b>- As Safety Car and field approach</p> <p><i>Speed of the Cars:</i>            VER 86 km/h            LEC 99 km/h            PER 106 km/h            OCO 117 km/h            HAM 104 km/h            ALO 109 km/h            RUS 104 km/h            RIC 106 km/h            TSU 115 km/h            MSC 110 km/h            STR 101 km/h            MAG 122 km/h            NOR 105 km/h            BOT 95 km/h            LAT 80 km/h            VET 85 km/h            ZHO 82 km/h</p>

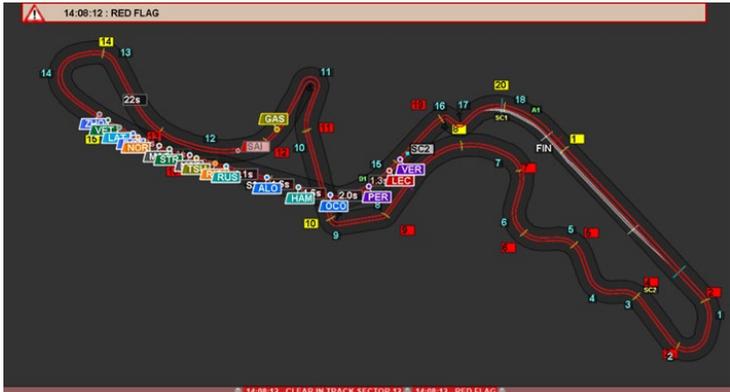
<p><b>14:08:13</b> <b>RED FLAG</b></p>

<p><b>14:08:14</b> Car #10 (GAS) passes <b>“Incident 1”</b> (189 km/h)</p> <p>Marshals move back out the way</p>

- Having recovery cranes on track at Suzuka during these weather conditions is an extremely sensitive matter.
- Nevertheless, and without undermining responsibilities regarding safety on track, we must also consider as detailed above that GAS drove in a reckless manner by not respecting the flags, thereby ignoring the basic safety rules.

- As the weather conditions were changing, it is concluded that it may have been better to delay the deployment of the recovery vehicles on track. However, the potential situation that GAS could have lost control of his car and collided with the stationary damaged car, a driver walking across the track and/or any marshals on track, must also be considered. In addition, in the event of a serious incident the Medical Car and staff could also have attended the scene.

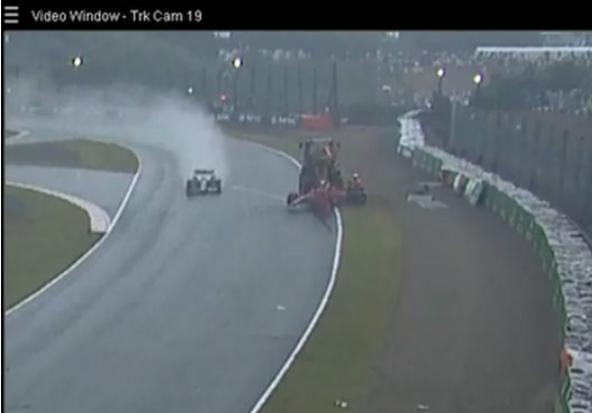
- GAS's speed was at 189km/h on arrival at **Incident 1** (SAI) and 163km/h at **Incident 2** (ALB recovery car) while under red flags. In neither of these two cases were GAS's car speeds compatible with the obligation to slow down and be able to stop his car.

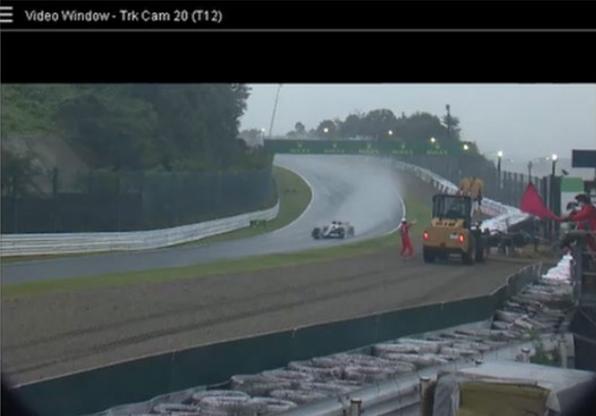
TIMING	EVENTS
<p><b>14:08:20</b> Car #10 (GAS) passes <b>"Incident 2"</b> (163 km/h).</p> <p>Car #10 (GAS) then accelerates up to a maximum of 250 km/h for the rest of the lap</p>

- After T12, whilst still under red flags, GAS's car #10 was still reaching speeds of between 200km/h and 250km/h.

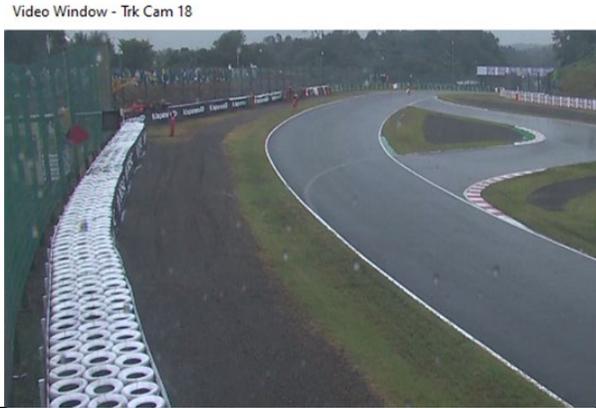
<p><b>14:09:24</b> All cars, including Car #10 (GAS), enter the pit lane</p> <p><b>14:11:46</b> Crane with Car #55 (SAI) exit the track – <b>"Incident 1"</b></p>
